Re: Notice of Violation
RCRA Compliance Evaluation Inspection – Epiworks, Inc.
EPA ID No.: ILR 000 103 317

COMPLIANCE EVALUATION INSPECTION REPORT

INSTALLATION NAME: Epiworks, Inc.
U.S. EPA ID. No.: ILR 000 103 317
LOCATION ADDRESS: 1606 Rion Drive
Champaign, Illinois 61822
DATE OF INSPECTION: November 20, 2015
U.S. EPA INSPECTORS: Sheila Burrus, RCRA Hazardous Waste

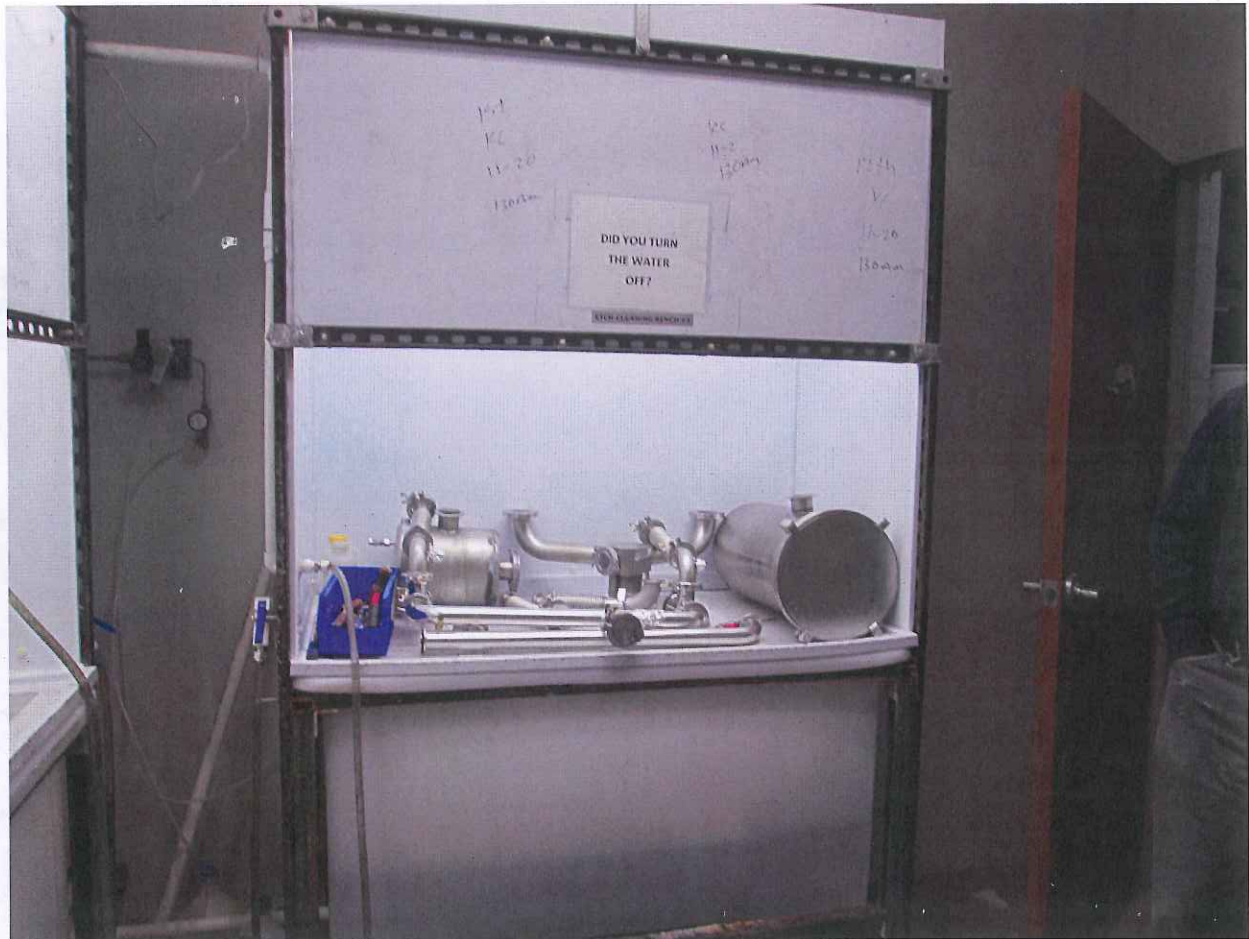
PHOTOGRAPH: 1

The tour began in the etch room located in building 1604, where equipment parts are cleaned (Photograph 1).

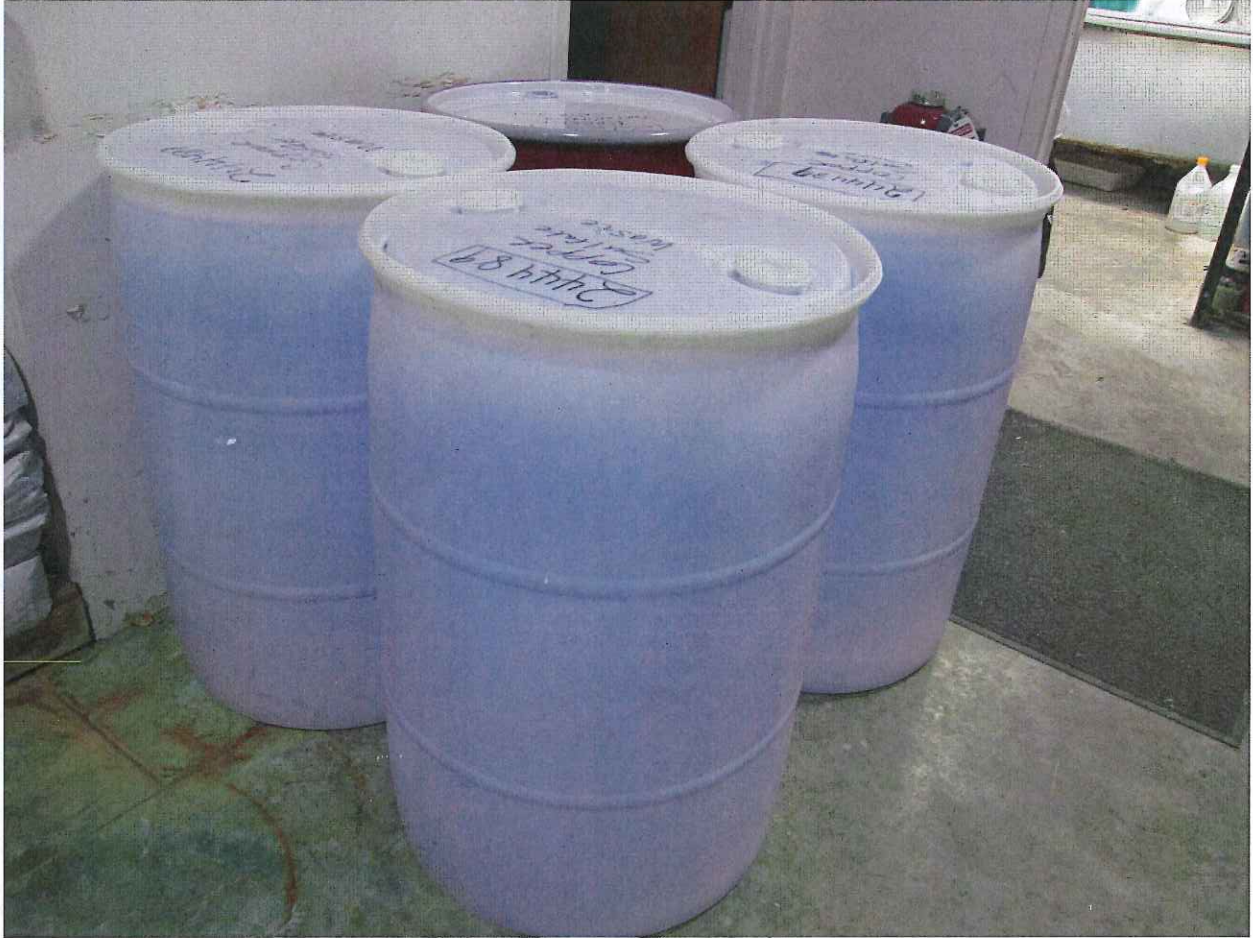
PHOTOGRAPH: 2

Next, we proceeded to the 90-day storage area, where I observed three 55-gallon containers of copper sulfate hazardous waste and one 55-gallon container of arsenic solid waste (Photographs 2 and 3). The containers were not marked with hazardous waste labels or accumulation start dates. Mr. Dickinson stated that Epiworks stopped putting hazardous waste labels on the containers since Biodine (the transporter) affixed hazardous waste labels to the containers when they pick them up for transport off-site. I informed Mr. Dickinson that the generator regulations state that hazardous waste labels must be affixed to containers as soon as they are stored in the 90-day hazardous waste storage area, and must include the date the drum became full.

90-day hazardous waste storage area (Building 1604-Shop Area)

At the time of the inspection, three 55-gallon containers of copper sulfate waste and one 55-gallon container of arsenic solid waste were not marked with the date upon which the period of accumulation of hazardous waste began.

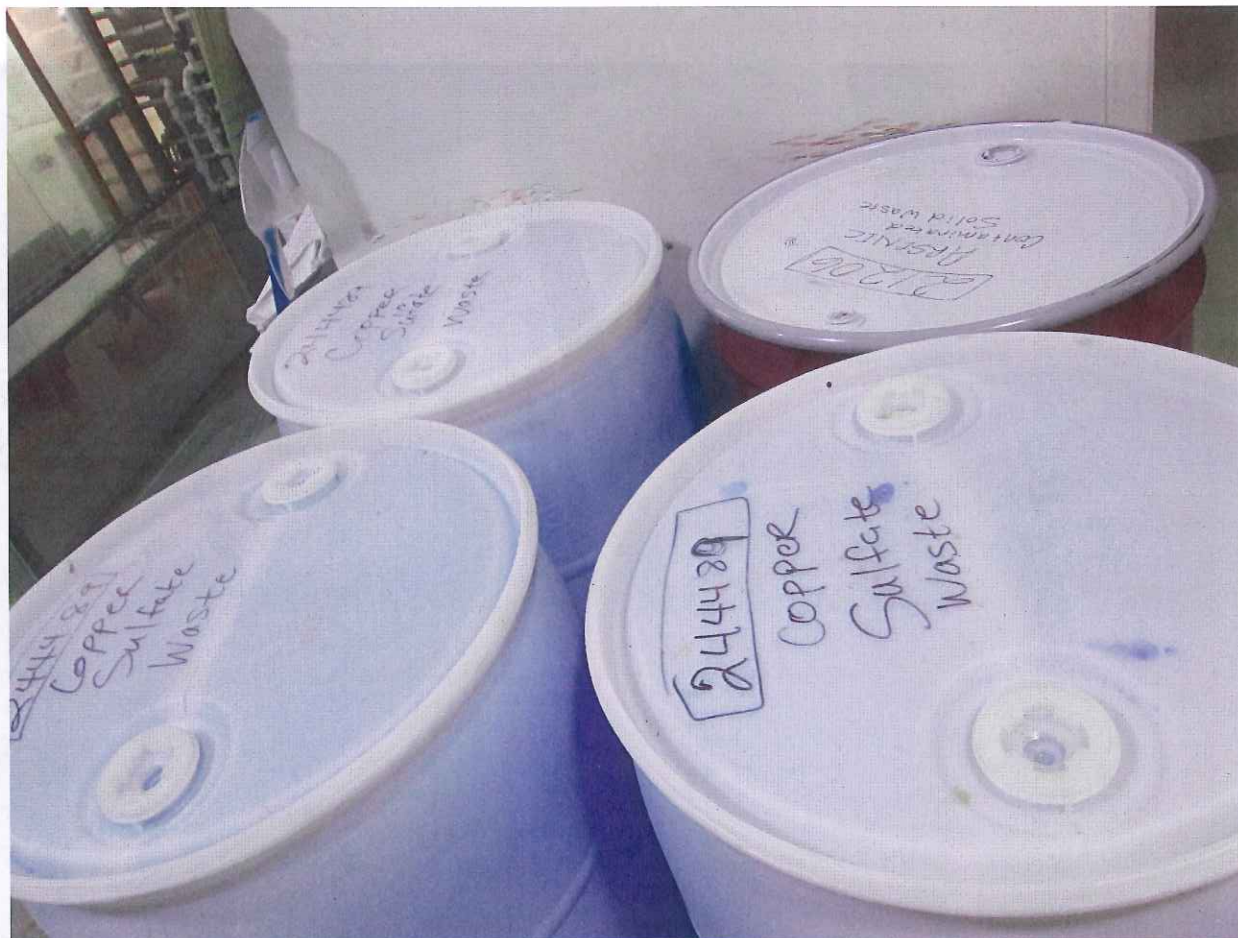
PHOTOGRAPH: 3

90-day hazardous waste storage area (Building 1604-shop area)

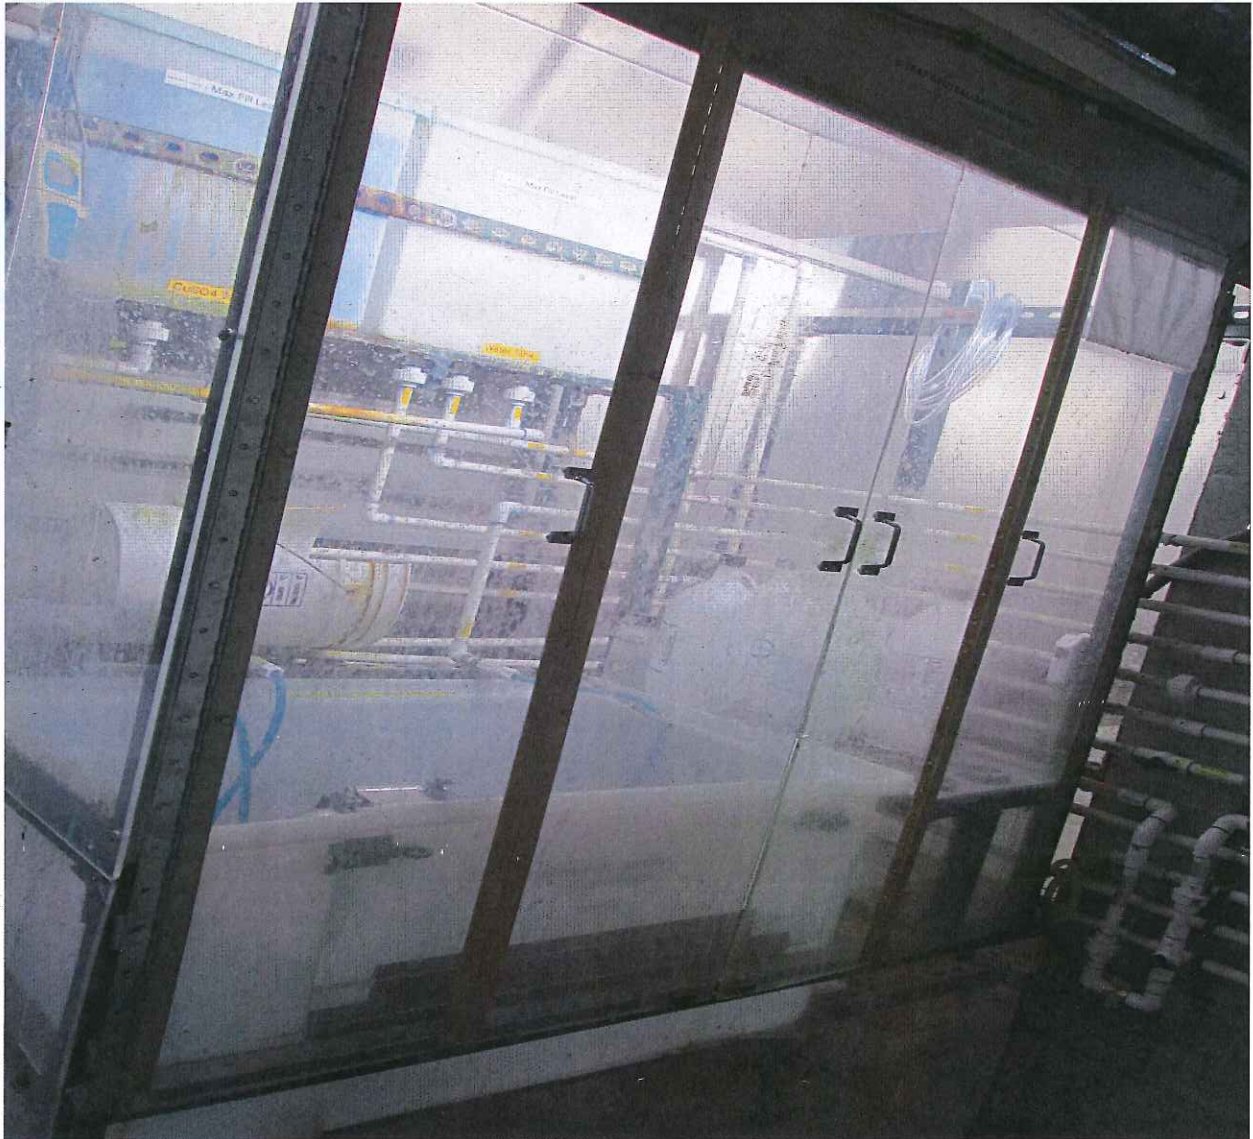
We proceeded to the P-Trap neutralization bench where copper sulfate waste is generated (Photograph 4) and then to the satellite accumulation area where I observed one 135-gallon container of arsenic contaminated solid waste, one 55-gallon containers of arsenic contaminated solid waste, one 55-gallon container of IPA/H₂O waste, one 55-gallon container of acid contaminated solid waste, one 55-gallon container of solvent contaminated waste and one 55-gallon container of copper/arsenic debris (Photograph 5). All above containers had written descriptions of their contents on the container.

PHOTOGRAPH: 4	
NAME OF PHOTOGRAPHER:	Sheila Burrus
DATE OF PHOTOGRAPH:	November 20, 2015
LOCATION OF PHOTOGRAPH:	90-day hazardous waste storage area (Building 1604-Shop Area)
SCENE BEING PHOTOGRAPHED:	P-Trap Neutralization Bench
SITE LOCATION:	1606 Rion Drive Champaign, IL 68122
INSTALLATION NAME:	Epiworks, Inc.
INSTALLATION I.D. #	ILR000103317

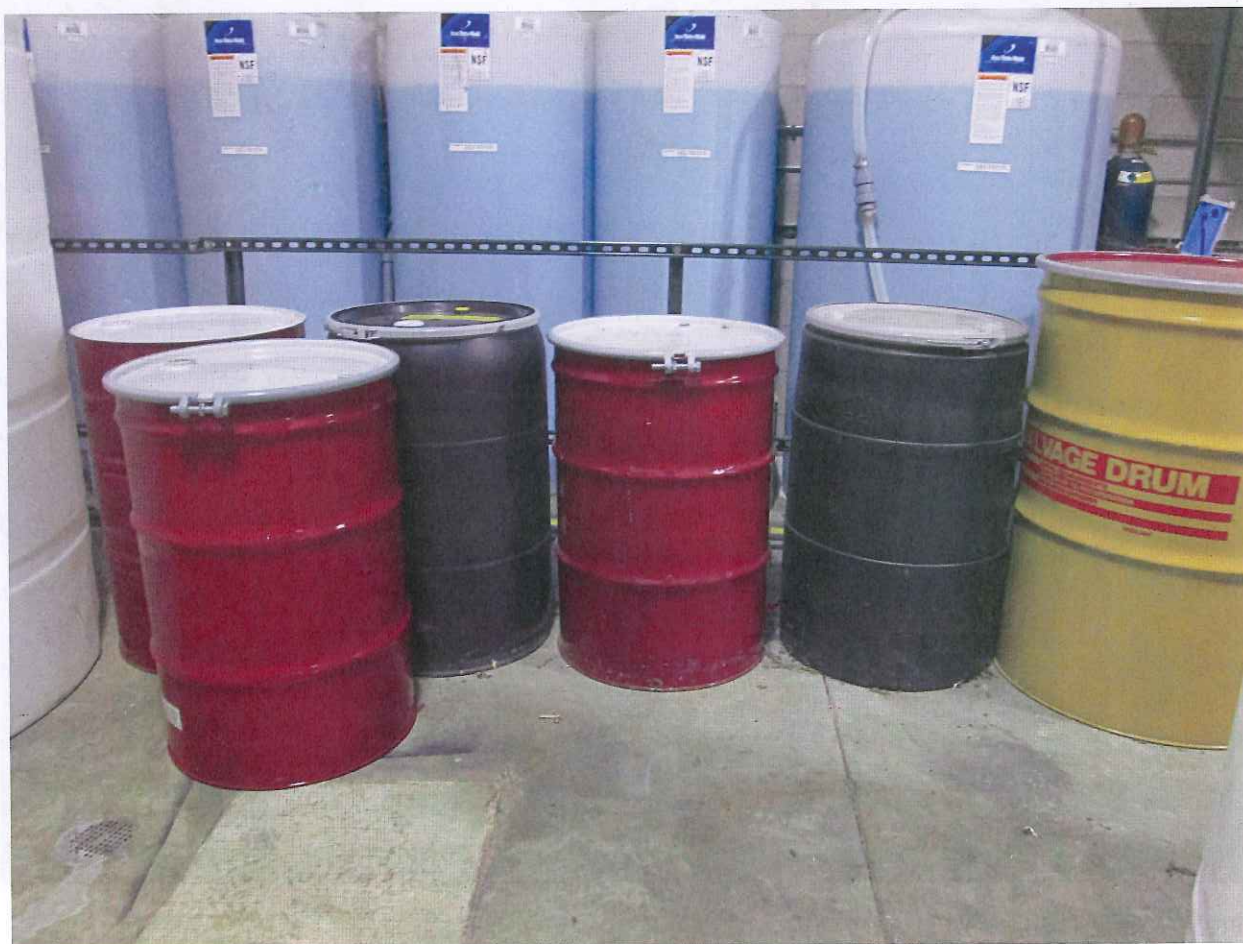
PHOTOGRAPH: 5

Satellite Accumulation Area (located directly across from 90-day hazardous waste storage area)

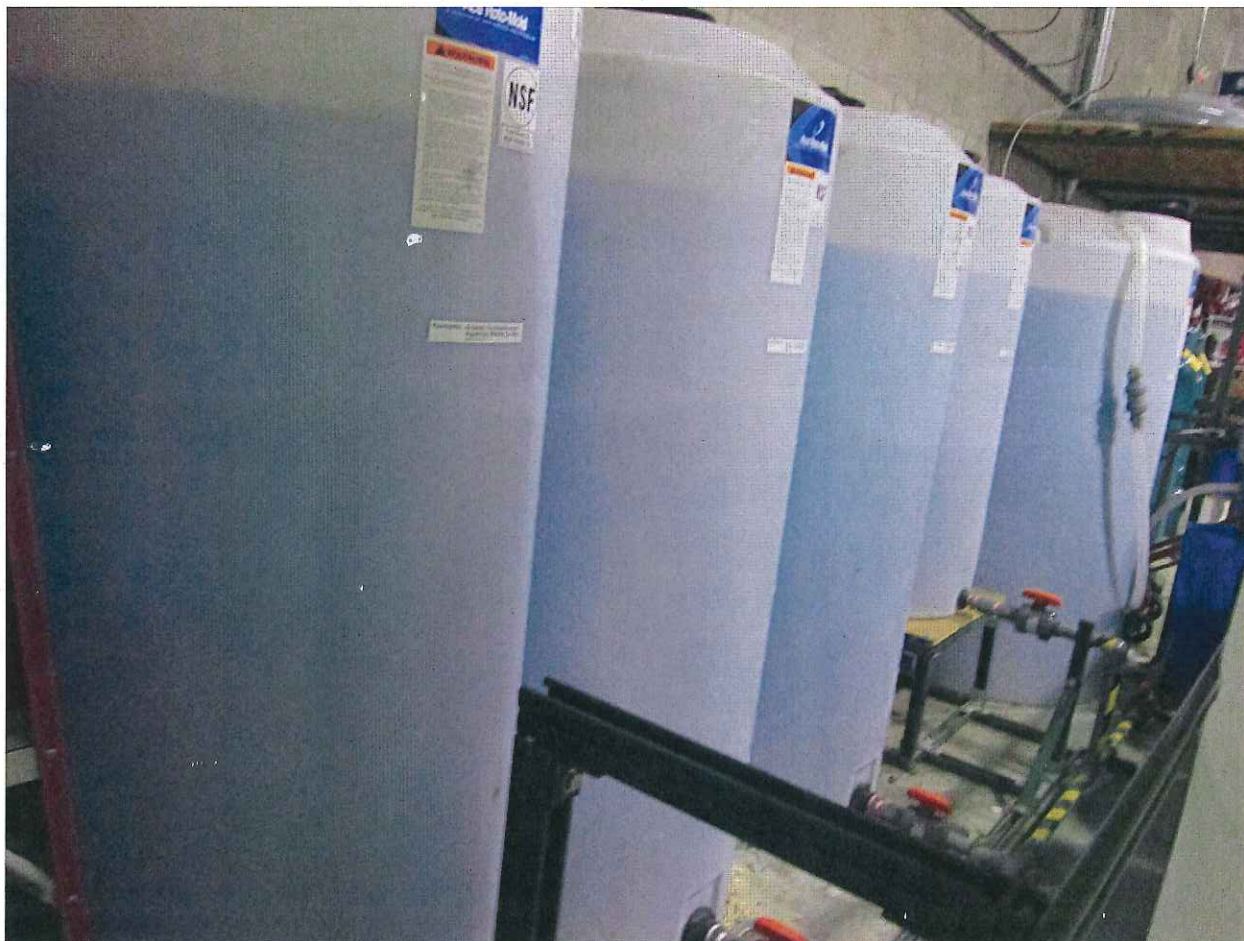
After inspecting the satellite accumulation area I began to inspect the bulk storage tanks which were located directly behind the satellite accumulation containers. There were five unlabeled hazardous waste bulk storage tanks containing arsenic contaminated aqueous waste (Photographs 6 through 10). There were one 400-gallon, three 225-gallon and one 150-gallon bulk storage tanks.

PHOTOGRAPH: 6
NAME OF PHOTOGRAPHER: Sheila Burrus
DATE OF PHOTOGRAPH: November 20, 2015
LOCATION OF PHOTOGRAPH: (Hazardous Waste Bulk Storage Tanks) directly behind satellite accumulation area
SCENE BEING PHOTOGRAPHED: unlabeled five bulk arsenic aqueous hazardous waste storage tanks (one 400-gallon, three 225-gallon and one 150-gallon)
SITE LOCATION: 1606 Rion Drive
Champaign, IL 68122
INSTALLATION NAME: Epiworks, Inc.
INSTALLATION I.D. #: ILR000103317

At the time of the inspection, Epiworks indicated that it had not obtained written assessments of the integrity of its five hazardous waste bulk storage tanks.

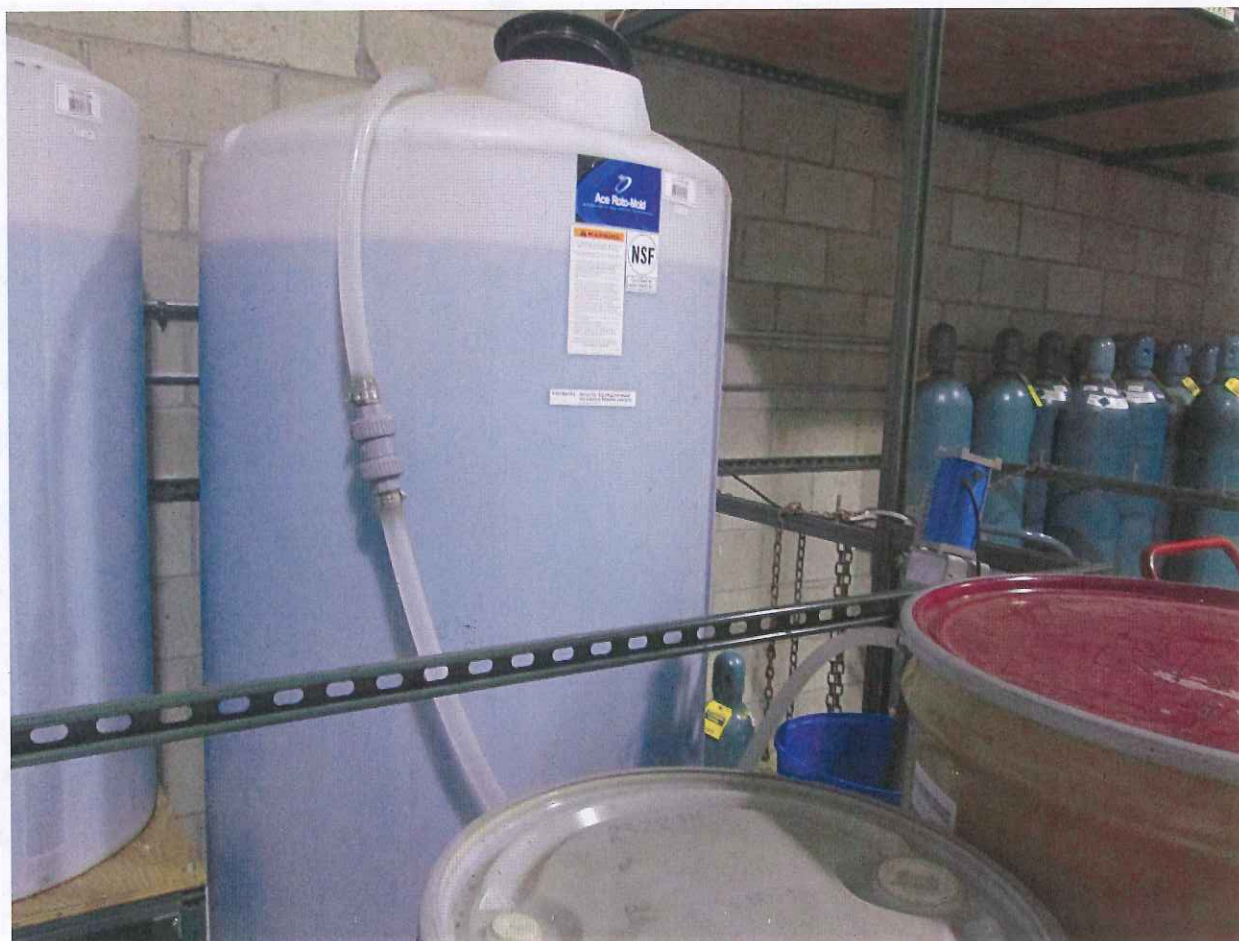
PHOTOGRAPH: 7

Hazardous Waste Bulk Storage Tanks (directly behind satellite accumulation area)

unlabeled bulk arsenic contaminated aqueous hazardous waste storage tanks

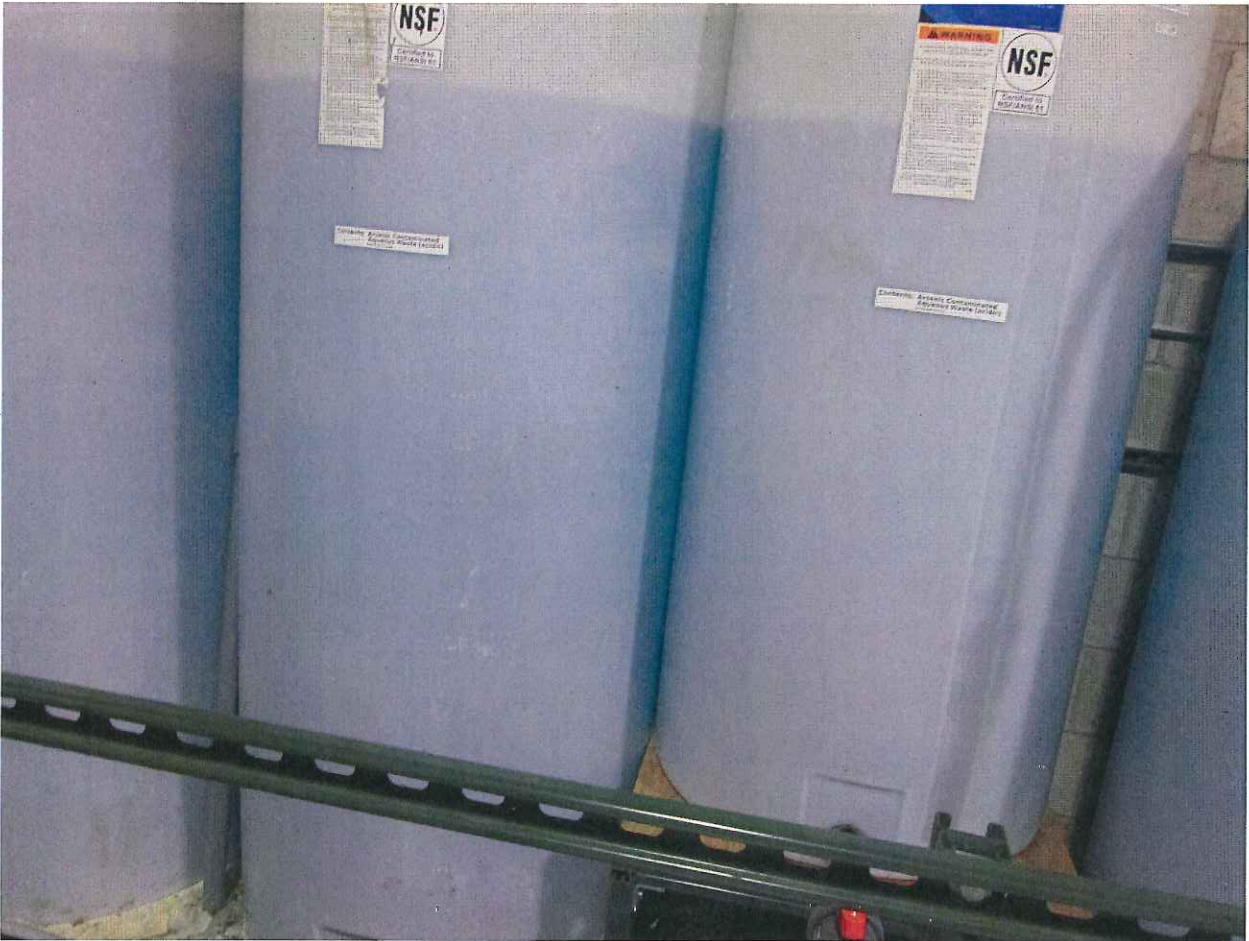
PHOTOGRAPH: 8
NAME OF PHOTOGRAPHER: Sheila Burrus
DATE OF PHOTOGRAPH: November 20, 2015
LOCATION OF PHOTOGRAPH: Hazardous Waste Bulk Storage Tanks (directly behind satellite accumulation area)
SCENE BEING PHOTOGRAPHED: unlabeled bulk arsenic contaminated aqueous hazardous waste storage tanks
SITE LOCATION: 1606 Rion Drive
Champaign, IL 68122
INSTALLATION NAME: Epiworks, Inc.
INSTALLATION I.D. # ILR000103317

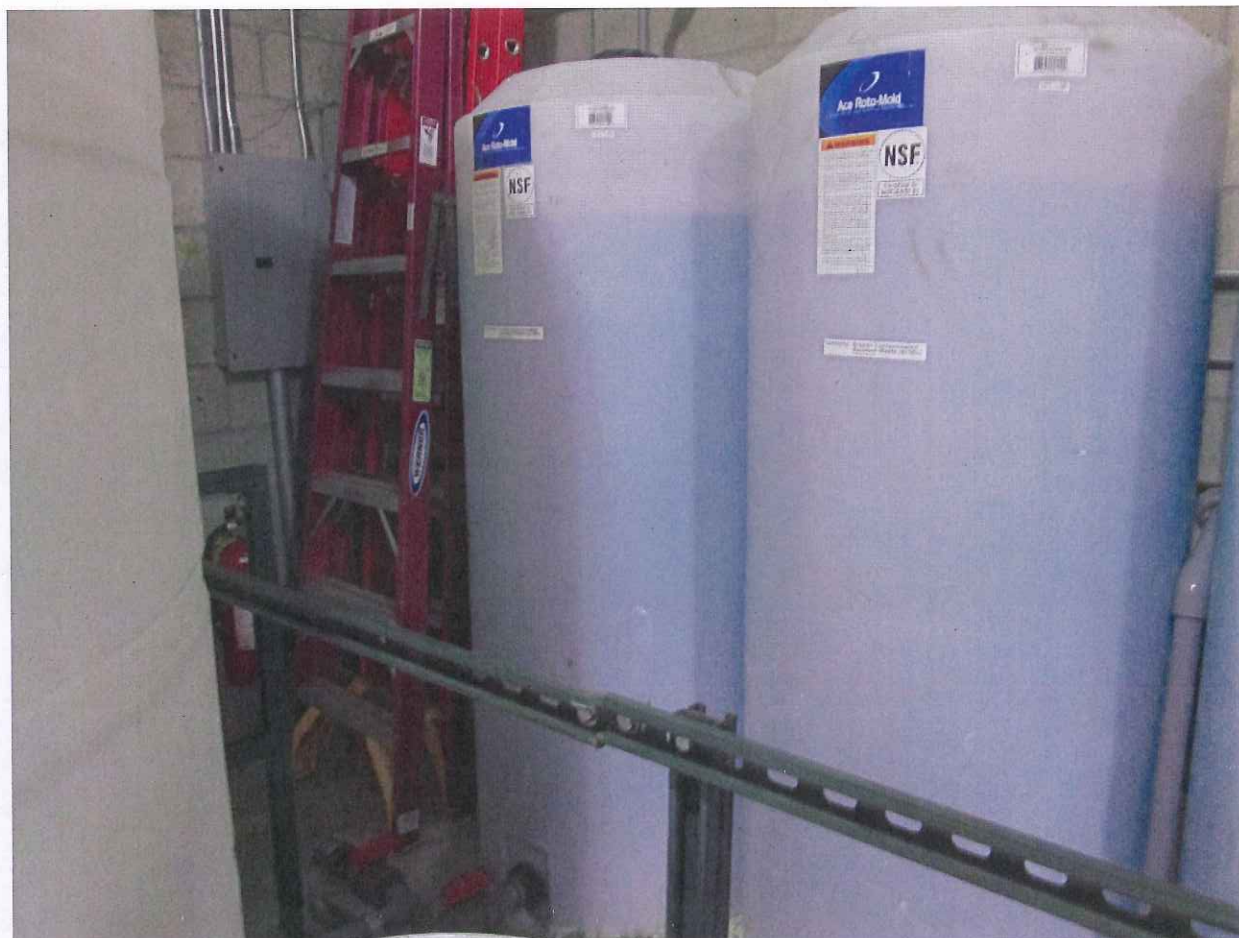
PHOTOGRAPH: 9

Hazardous Waste Bulk Storage Tanks (directly behind satellite accumulation area)

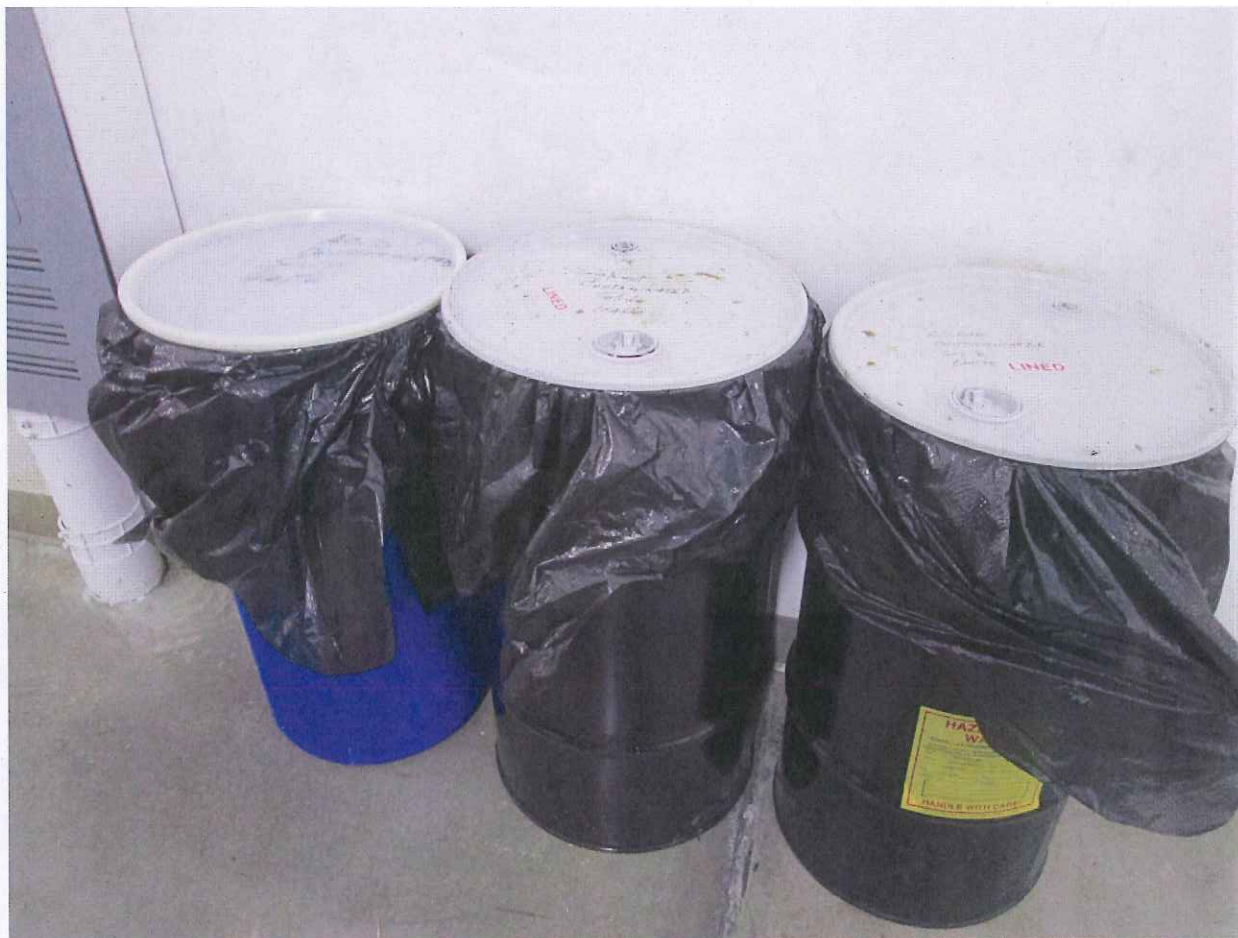
PHOTOGRAPH: 11

We then proceeded to clean rooms 1 and 2. I observed one 15-gallon satellite accumulation container of acid contaminated solid waste, one 15-gallon satellite accumulation container of solvent contaminated solid waste and one 15-gallon satellite accumulation container of contaminated solid waste located directly outside of clean room 1. I observed one 55-gallon satellite accumulation container of arsenic contaminated aqueous waste near clean room 2. The 15-gallon containers of waste are generated from clean rooms 1 and 2. The 55-gallon container of waste is generated from the cleaning bench in clean room #1 (Photographs 11 and 12). All containers were closed and labeled with a description of their contents.

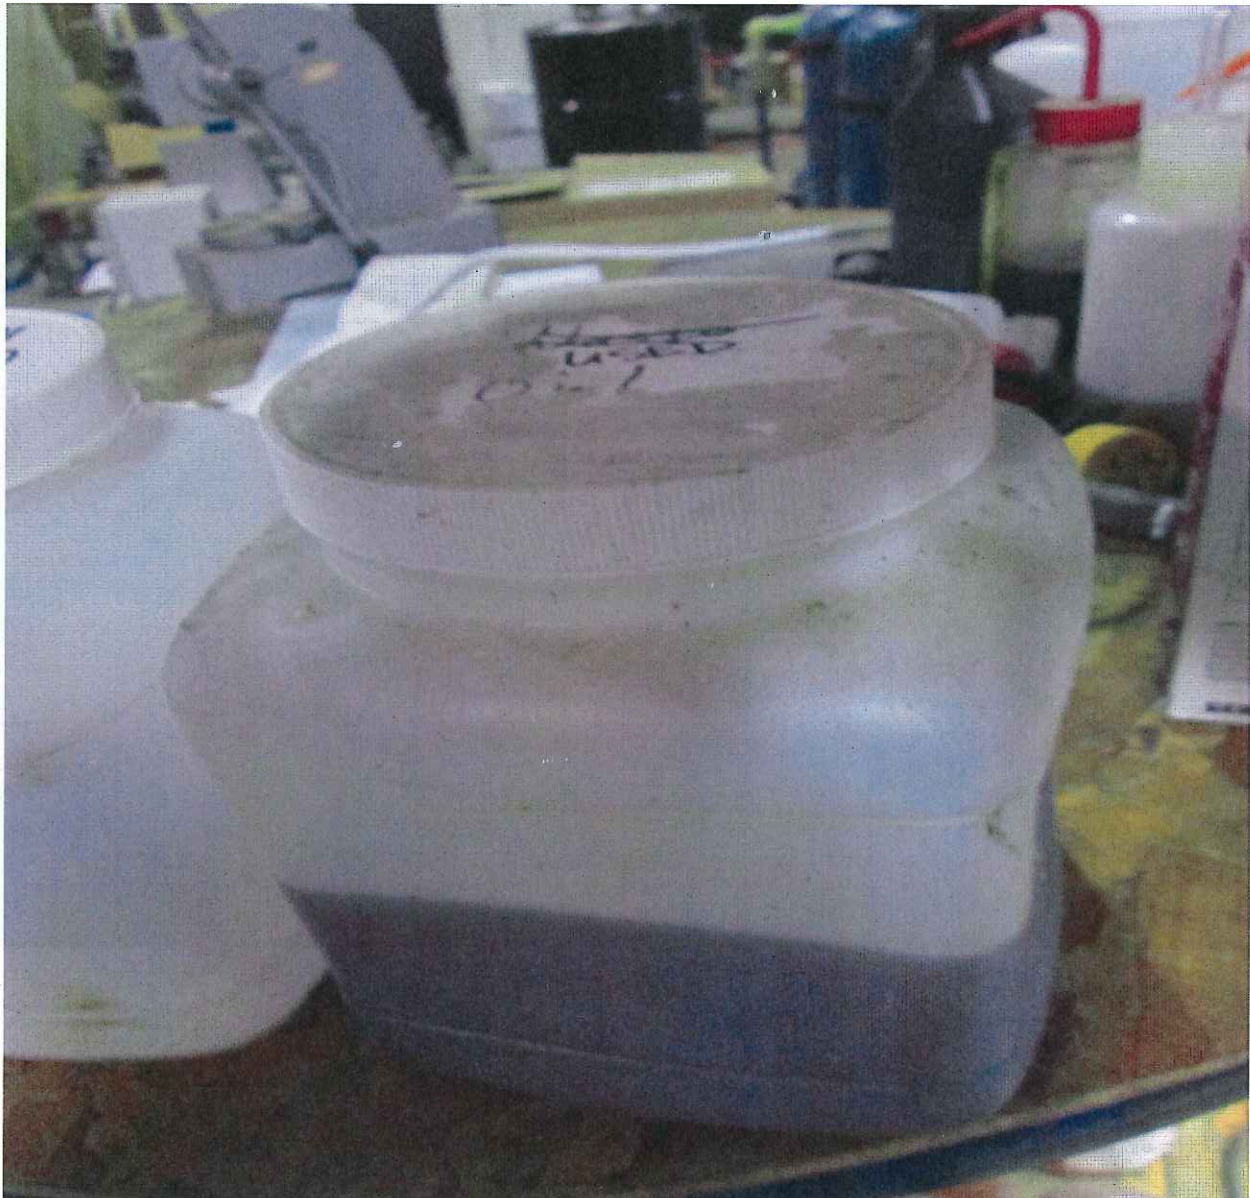
PHOTOGRAPH: 14

container storing ½ gallon of used oil (Photograph 13). The container was labeled waste oil instead of used oil, but immediately changed to read “used oil” at the time of the inspection (Photograph 14). Mr. Dickinson then explained that the used oil is mixed with the solvent waste for disposal. Epiworks generates appropriately 10gallons of used oil per year.

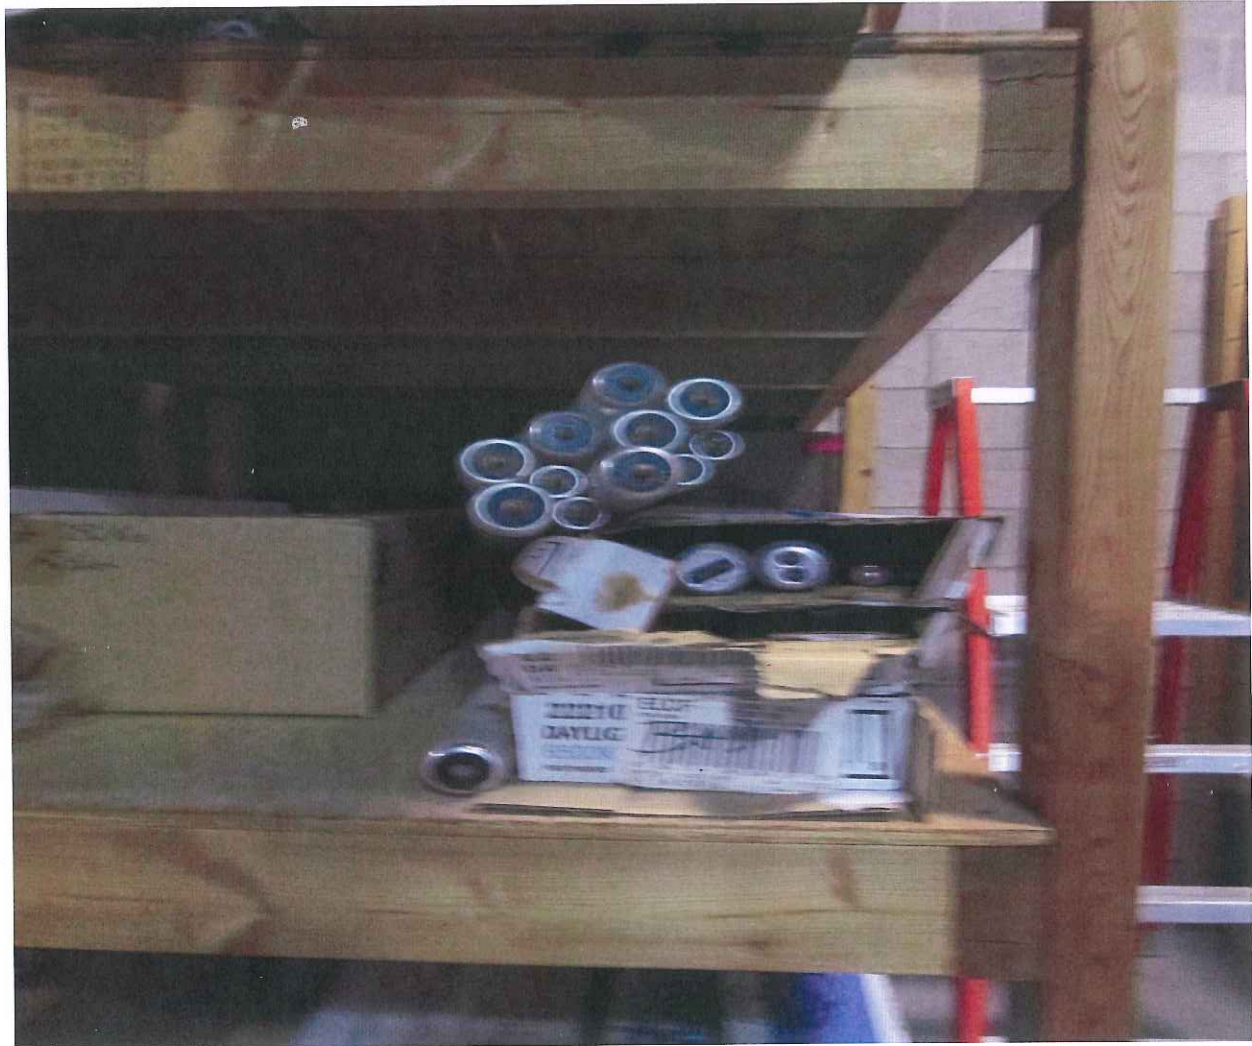
PHOTOGRAPH: 15

We proceeded to the universal waste storage area where I observed three unlabeled and open containers of waste lamps and twelve loose lamps (Photograph 15).

12 loose waste lamps not in container

At the time of the inspection, Epiworks was storing waste lamps in open containers as well as without an adequate container or package.

At the time of the inspection, Epiworks was storing waste lamps without any of the above phrases.
